Navajo Abandoned Uranium Mine

Site Screen Report

Mine Name: Yazzie No. 101

Mine ID: 132

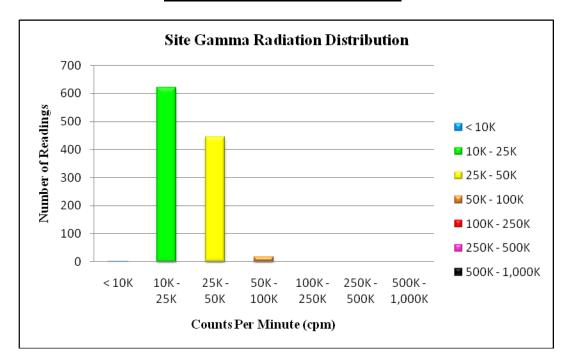
Highest gamma radiation measurement: 83,094 counts per minute (cpm)

Background Average: 15,819 cpm **Two Times Background:** 31,637 cpm

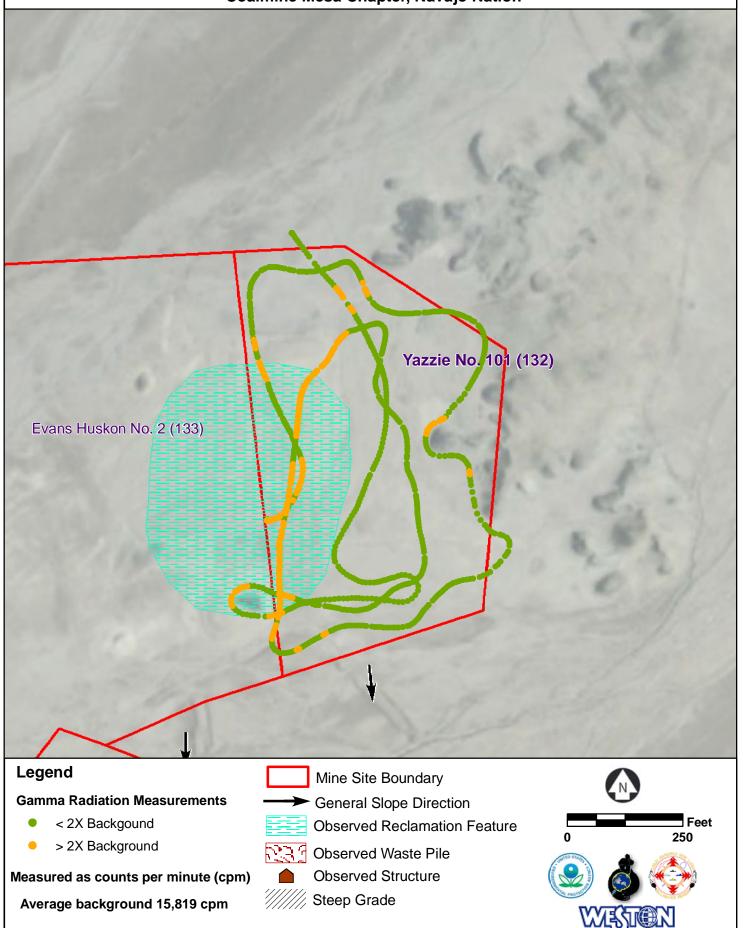
Figure 1 - Gamma Radiation Measurements, Above Two Times Background Yazzie No. 101 (132) Coalmine Mesa Chapter, Navajo Nation

A total of 1,085 gamma radiation measurements were collected from the mine site, ranging from 9,926 cpm to 83,094 cpm. Measurements collected in the vicinity of the mound near former pond were found at a maximum level of approximately 80,000 cpm. The measurements are represented in Figures 1 and 2.
